LEVEE STABILITY

Three Rivers Levee Improvement Authority

Levee Repairs Project Phases 1, 2 and 4

4-19-2007

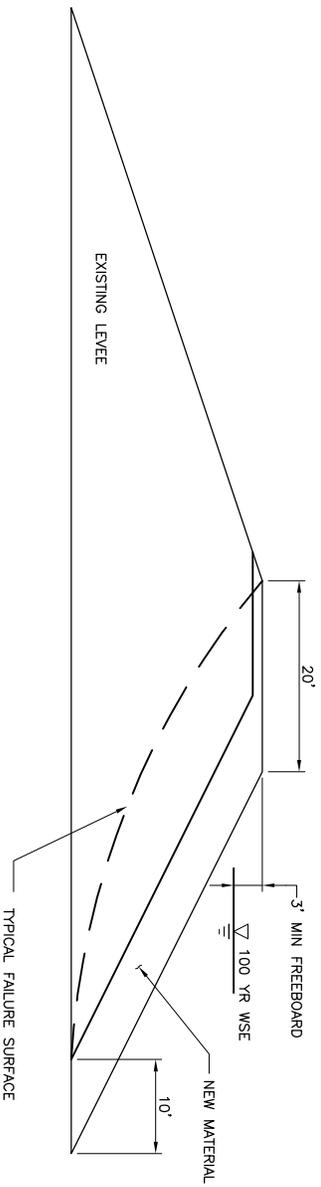
TYPICAL FAILURE SURFACE
NTS

In the vast majority of the cases the new fill was placed in a narrow layer (2 to 3 feet wide) on the waterside of the levee and/or on the crown of the levee (above the 100-year water surface elevation). In these cases, neither the strength nor permeability of the placed material is critical to the overall performance of the levee embankment. This is illustrated in the attached Figure 1 which shows the relationship of the placed fill to a typical critical failure surface and the 100-year water surface elevation.
